Recognizing and Addressing Moisture Concerns

by Mike Endredi

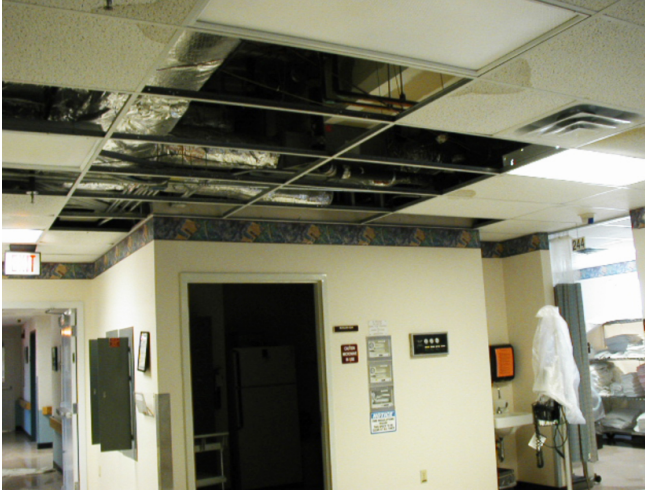
(Figure 1 The source of water within a building is often difficult to identify.)

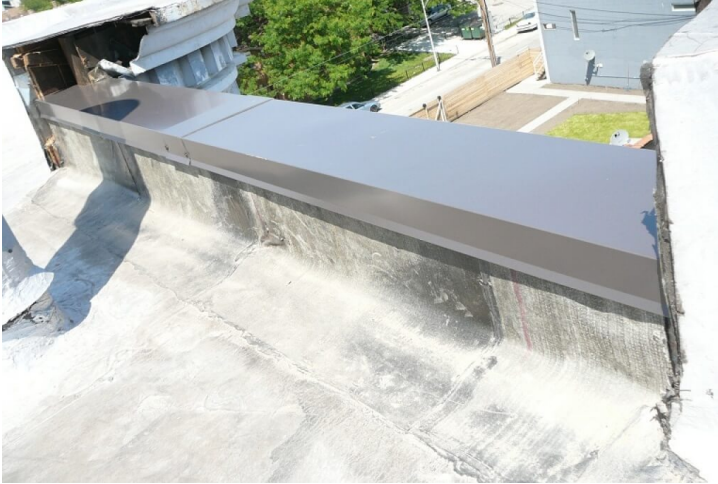
(Figure 2 A thorough roof investigation requires investigation of flashings for cracks.)

Visual investigation is the simplest and most easily accomplished method of investigation. Visual investigation can be used to generate theories that can later be validated with other investigation techniques. Visual investigation involves casing a building and visually inspecting the roof and walls for obvious potential moisture sources. A comprehensive visual inspection may reveal failing materials, faulty installation or poor detailing—all potential sources of moisture within the building. Special attention should be placed upon details, joints, flashings and any other discontinuities or terminations. SPRI specifically recommends the following details in order of importance as critical for visual inspection:

- Cap Flashing
- Edge Metal
- Base Flashing
- Penetrations
- Field of Roof
- Ballast
- Roof adhesive and surface coatings

The NRCA “Manual of Roof Maintenance and Repair” reinforces SPRI’s emphasize on the criticality of flashing inspection and says that “many early roof problems are actually flashing problems” and that “the importance of maintaining them cannot be overemphasized.”

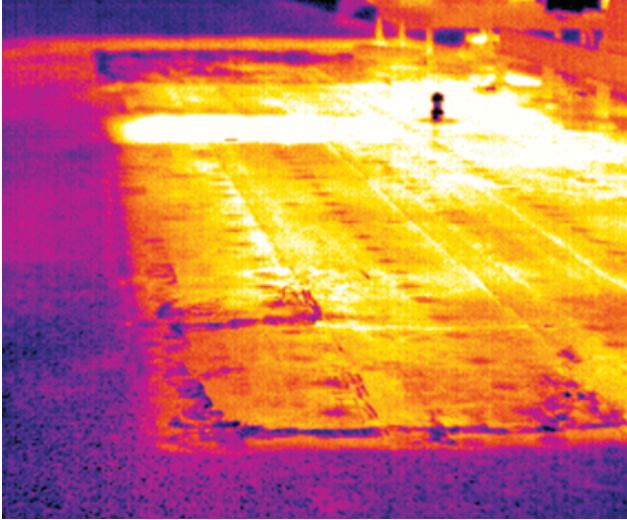
(Figure 3 Warm spots discovered in infrared scans indicate wet materials.)

If visual inspections do not conclusively establish a source of moisture intrusion, an infrared or nuclear scan can be used to shed more light on where moisture may be located in a roof assembly. Further, any issues or concerns revealed during a visual inspection can be validated by a moisture scan. Infrared scans are often performed at night when a roof or wall surface cools down as the heat absorbed from the sun dissipates. Because moisture retains heat better than most materials, warmer temperatures often indicate the presence of moisture. Thermal images provide a map of plausible moisture sources. Nuclear scans are necessary over gravel and ballast surfaced roof assemblies where infrared does not work as well. Once moisture scans are complete, core cuts should then be taken to visually verify the results.
